IN DEPTH INSPECTION REPORT

P.I.N. 3501.60

B.I.N. 1093561

BIN 1093561

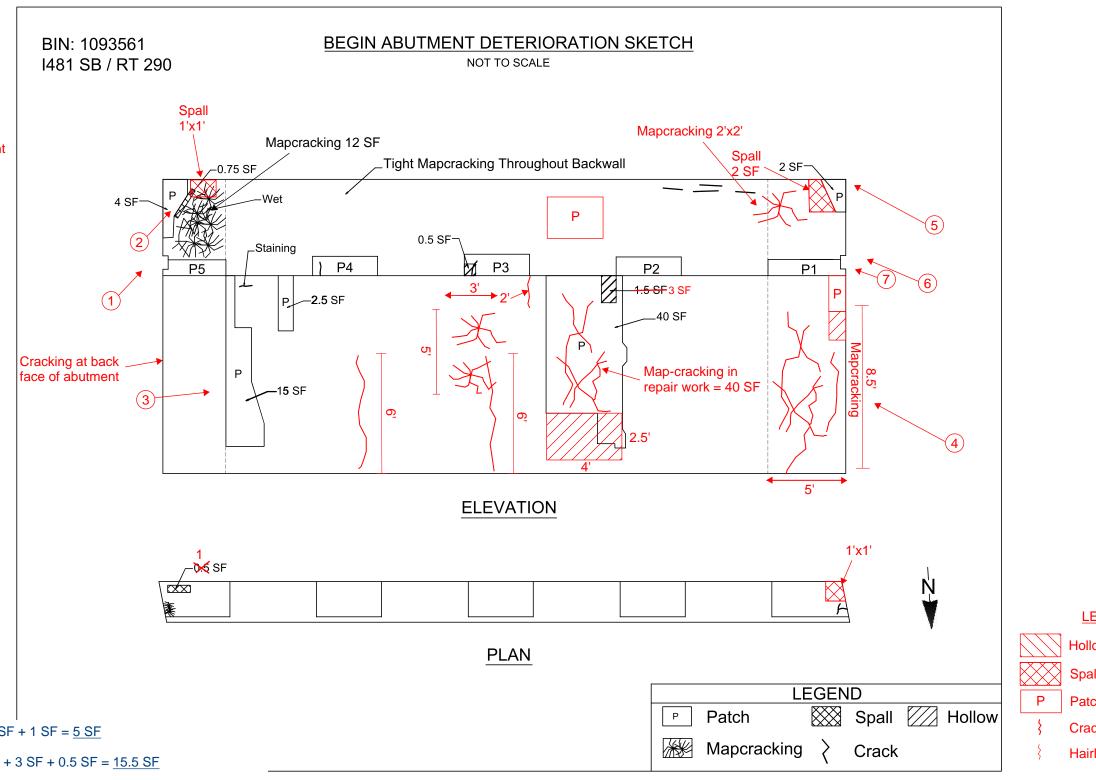
- 1) Spalling concrete fascia and mid wingwall
- 2 Spalling concrete fascia and backwall, rust staining on abutment
- (3) Abutment general view
- 4 Abutment general view, mapcracking, repair patch, flaking sealer
- (5) Spalling on concrete fascia, cracking and rust staining
- 6 Pedestal 1 cracking and rust staining
- (7) Pedestal 1 spalling, cracking and rust staining

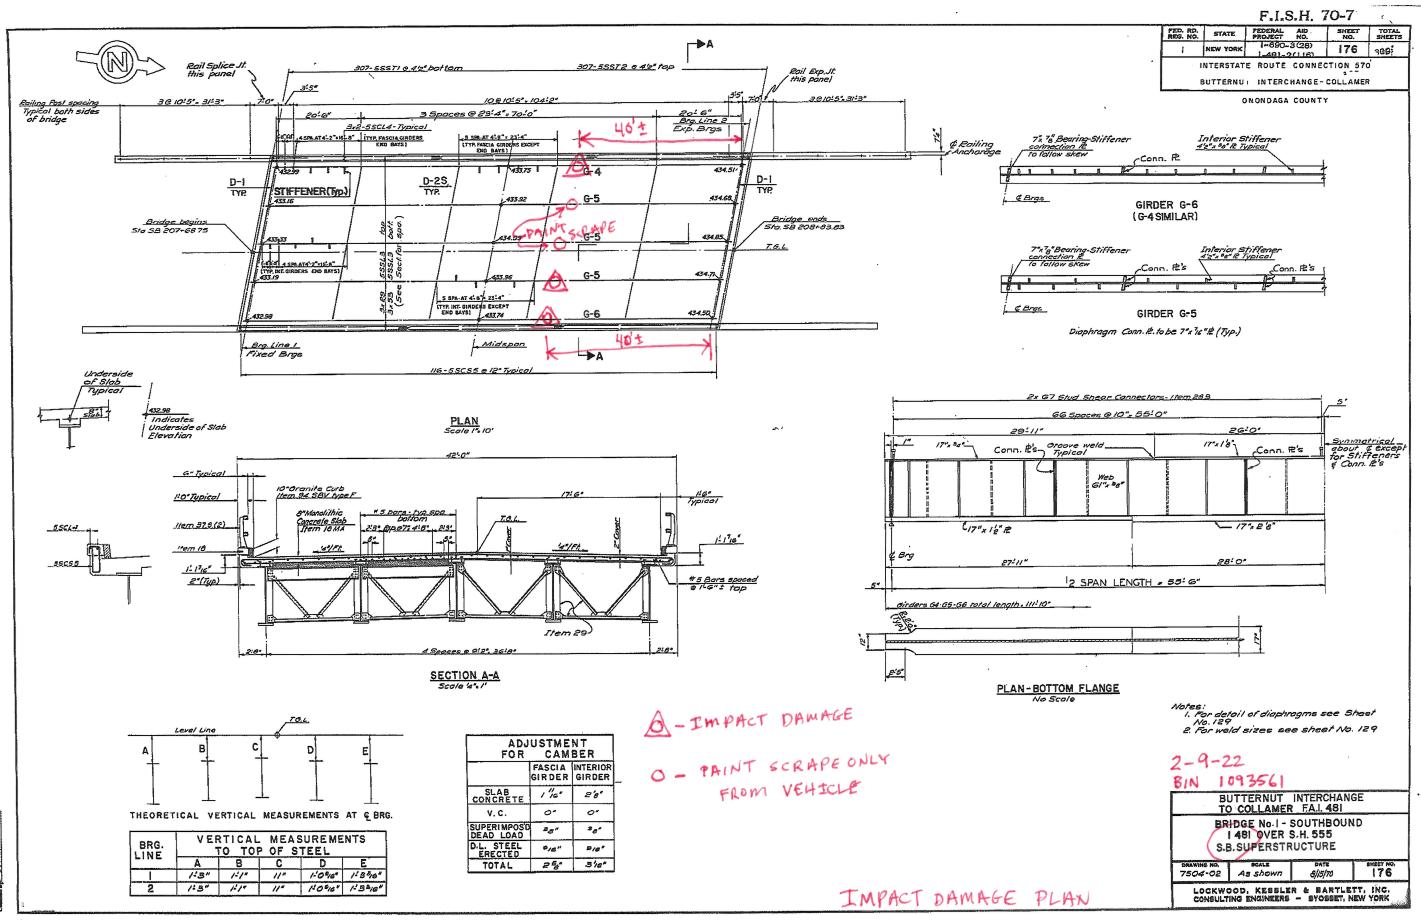
20) Girder 4 - Flaking paint, rust staining on backwall, pigeon waste

hazard (21) Girder 1 - Paint condition

22) Girder 1 - Impact damage to bottom flange
